# **Intel® Xeon® Processor E7-8800/ 4800 v4 Product Family**

**Specification Update**

*July 2018*

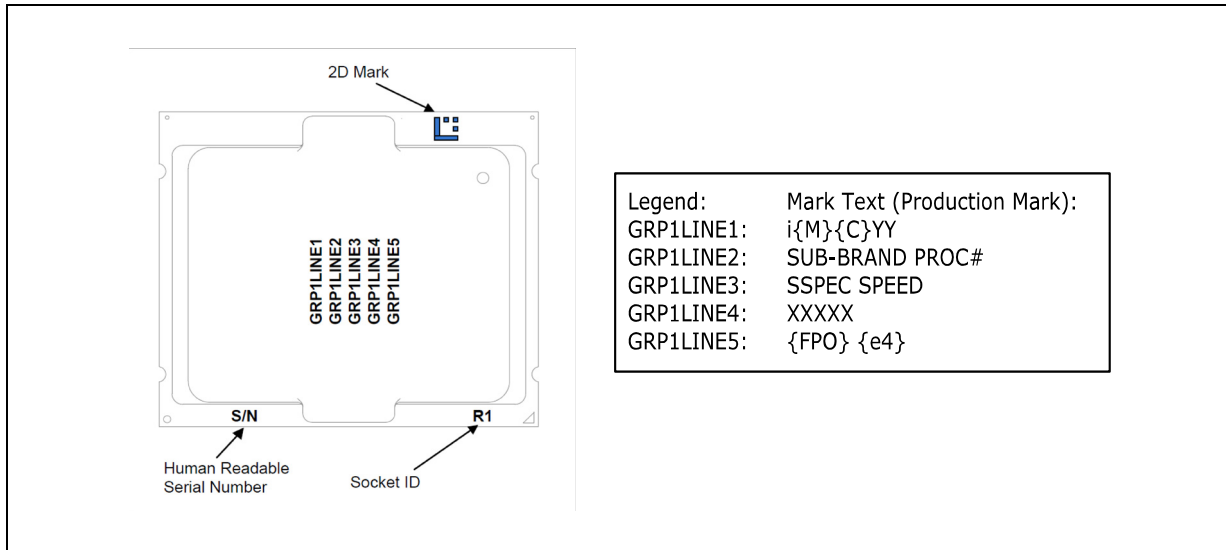
**Figure 1. Intel® Xeon® Processor E7-8800/4800 v4 Product Family Top-side Markings (Example)**

The Intel® Xeon® Processor E7-8800/4800 v4 Product Family stepping can be identified by the following component markings.
